PRODUCT RECALL
MDS-24-5154
4Fr Single Lumen PowerPICC

28 May 2025

Type of Field Action: Removal (Recall)

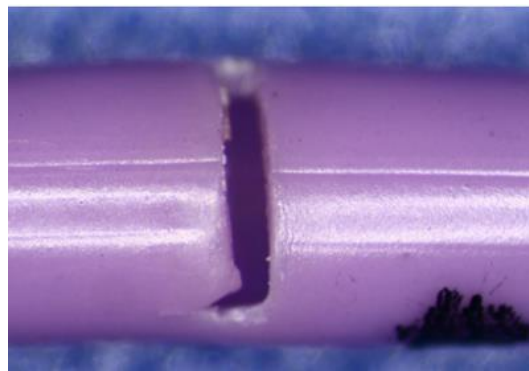
BD has seen an increase of material fatigue leaks on 4 Fr single-lumen PowerPICC catheters, both SOLO and non-SOLO versions, in specific geographies. These leaks are primarily characterized by a transverse/circumferential crack in the catheter body (Figure 1).

Figure 1: Example of transverse/circumferential crack in the catheter body

BD's investigation has identified certain factors that contribute to material fatigue leaks in the 4Fr single-lumen PowerPICC catheter body, specifically:

- The resin used to extrude the catheter tubing exceeded our supplier's specification for a material property called melt flow index (MFI). BD's investigation has concluded that a higher MFI could make the PowerPICC catheter body more susceptible to leakage when placed under stress.

- Insertion and securement techniques that contradict the PowerPICC IFU requirements, such as the requirement to insert the catheter as close to the zero mark as possible.

We have implemented additional controls around MFI that provides increased level of product assurance.

- BD is removing additional unexpired lots of 4 Fr. single-lumen PowerPICC, both SOLO and non SOLO versions, as described in letter.
- BD is notifying users to ensure practice is consistent with BD Instructions for Use (IFU) for insertion depth and securement.
- BD will provide product replacement or credit for all destroyed products.

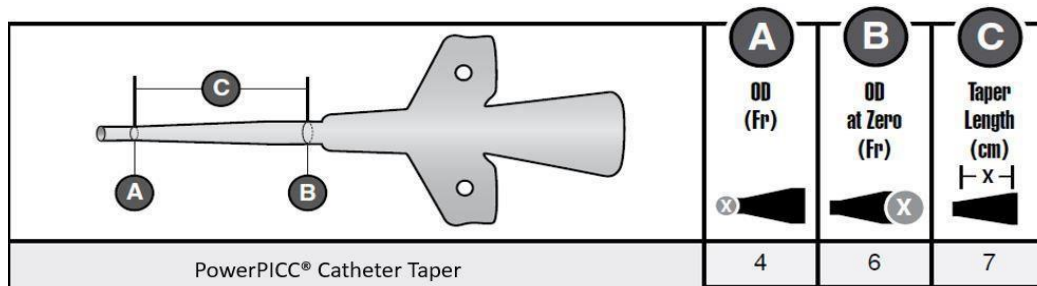
- BD PICCs have a taper design that increases in diameter near the zero-centimeter mark on the device.
 - When using any BD PICC, ensure practice is consistent with BD IFUs for insertion depth and securement, including insertion to the zero mark. Fully insert the PICC as close as possible to the zero-centimeter mark (position B in Figure 2). This allows the kink-resistant, tapered region to be utilized and is associated with lower catheter leakage rates.

Figure 2: Image of the PowerPICC Taper Region

- Select securement devices that can be used consistent with the BD PICC IFU.
